GALVIN POND DAM

NDI No. PA 00602

PHASE I INSPECTION REPORT
NATIONAL DAM INSPECTION PROGRAM

Galvin Pond Dam, Bradford County, Pennsylvania
NDI No. PA 00602, PennDER No. 8-63
West Branch of Trout Creek
Inspected 31 October 1980

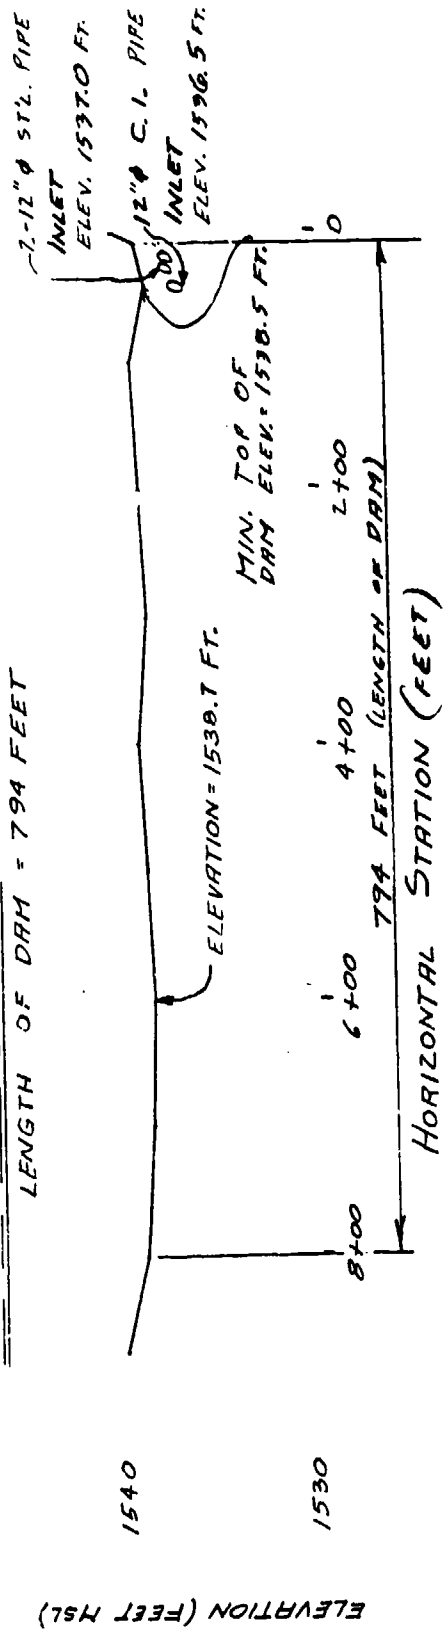
TOP OF DAM PROFILE (LOOKING DOWNSTREAM)

VISUAL EXAMINATION OF	OBSERVATIONS	REMARKS OR RECOMMENDATIONS
VERTICAL AND HORIZONTAL ALIGNMENT OF THE CREST	The minimum top of dam elevation is only slightly above the spillway outlet pipes. This area is approximately 6 in. below the average top of dam.	Fill this low area and reseed with grass.
